Debris/Ice/TPS Assessment and Integrated Photographic Analysis of Shuttle Mission STS-85

*Gregory N. Katnik
Process Engineering/Mechanical System Division/ET-SRB Branch,
Kennedy Space Center, Florida*

**DEBRIS/ICE/TPS ASSESSMENT
AND
INTEGRATED PHOTOGRAPHIC ANALYSIS
OF
SHUTTLE MISSION STS-85**

7 August 1997

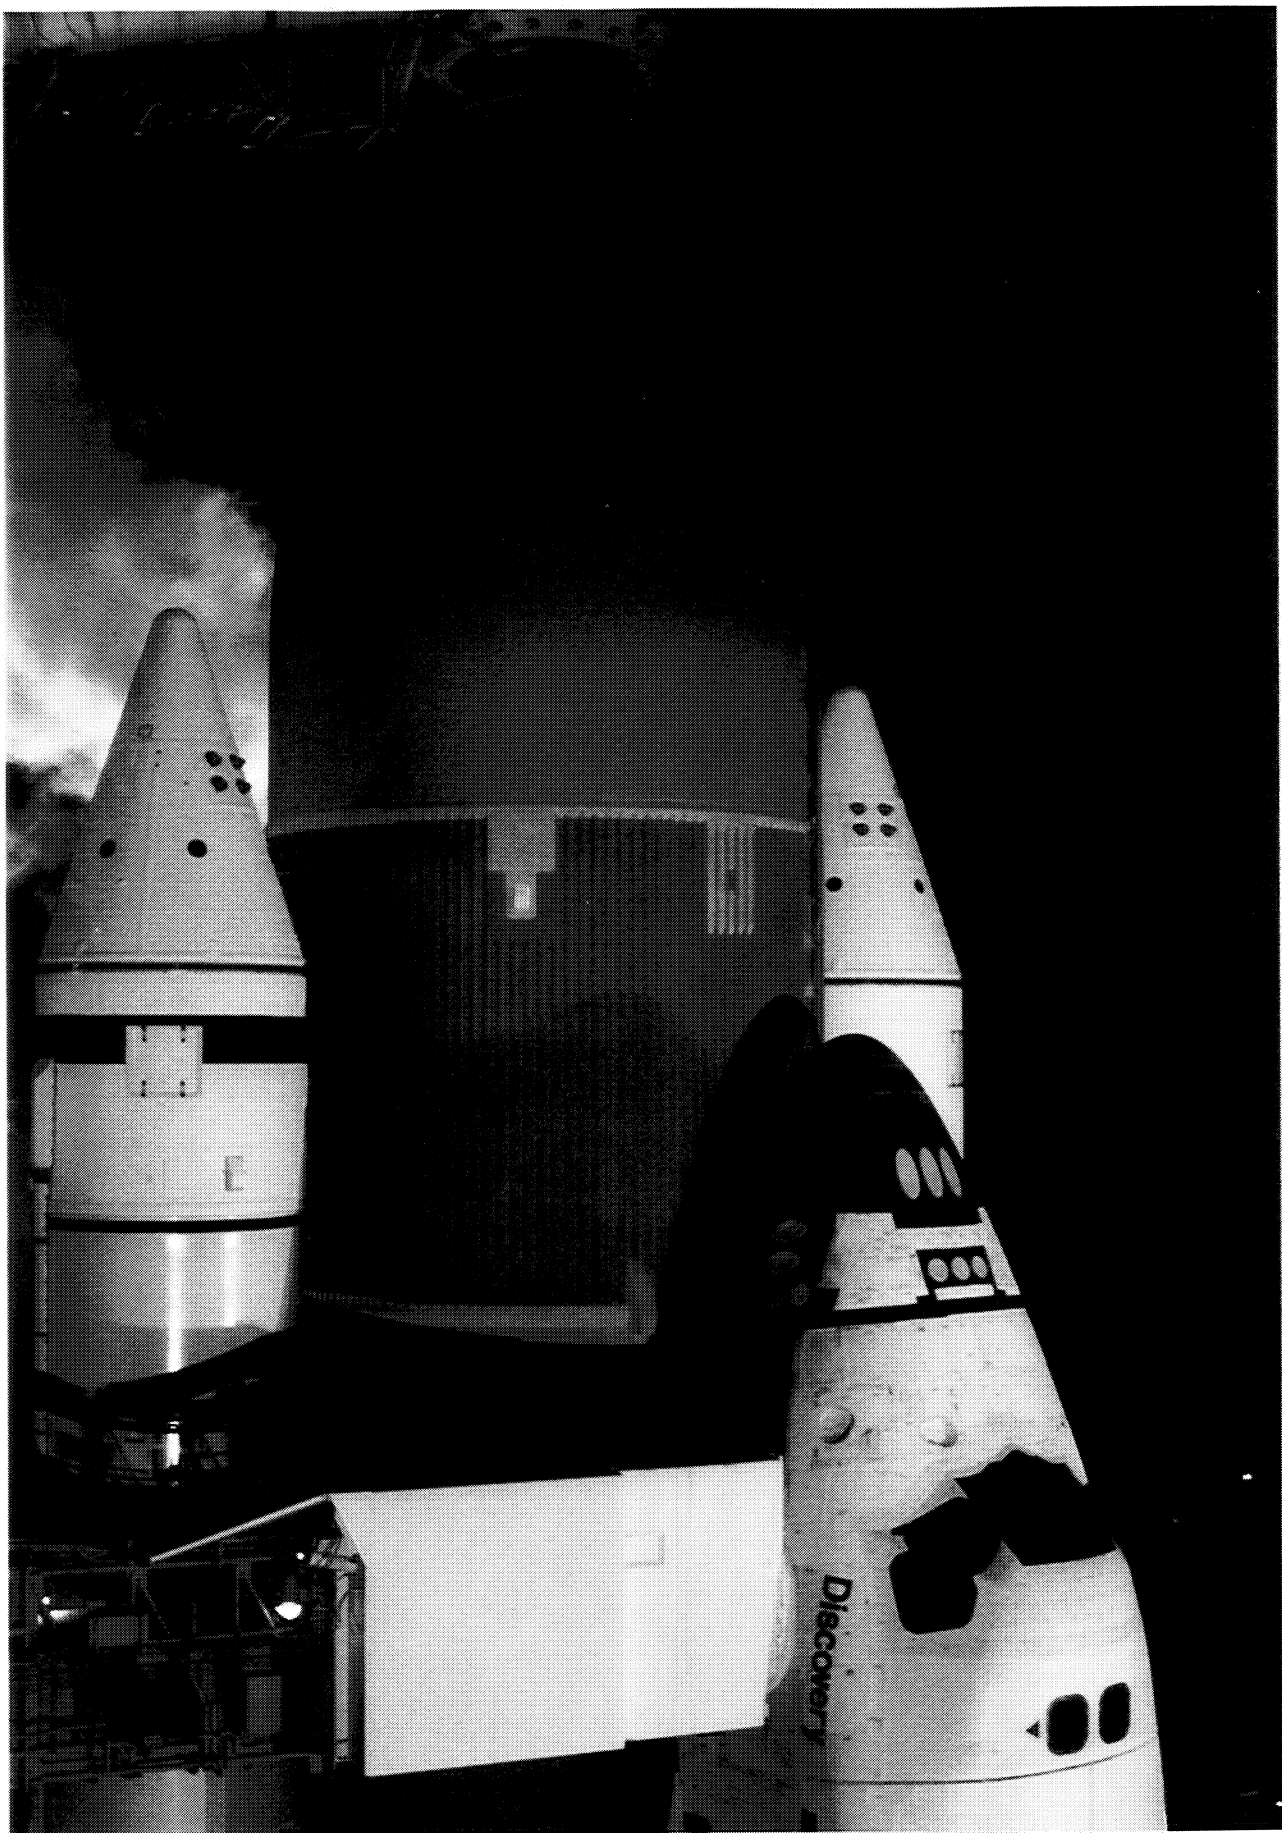
Photo 3: LO2 Tank and Intertank After Cryoload

The Final Inspection Team observed moderate condensate, but no ice or frost accumulations, on the LO2 tank acreage. TPS surface temperatures averaged 67 degrees F. A small repair on the +Z barrel section was intact with no visible frost lines.

The Final Inspection Team observed light condensate, but no ice or frost accumulations, on the LO2 tank. TPS surface temperatures averaged 67 degrees F.

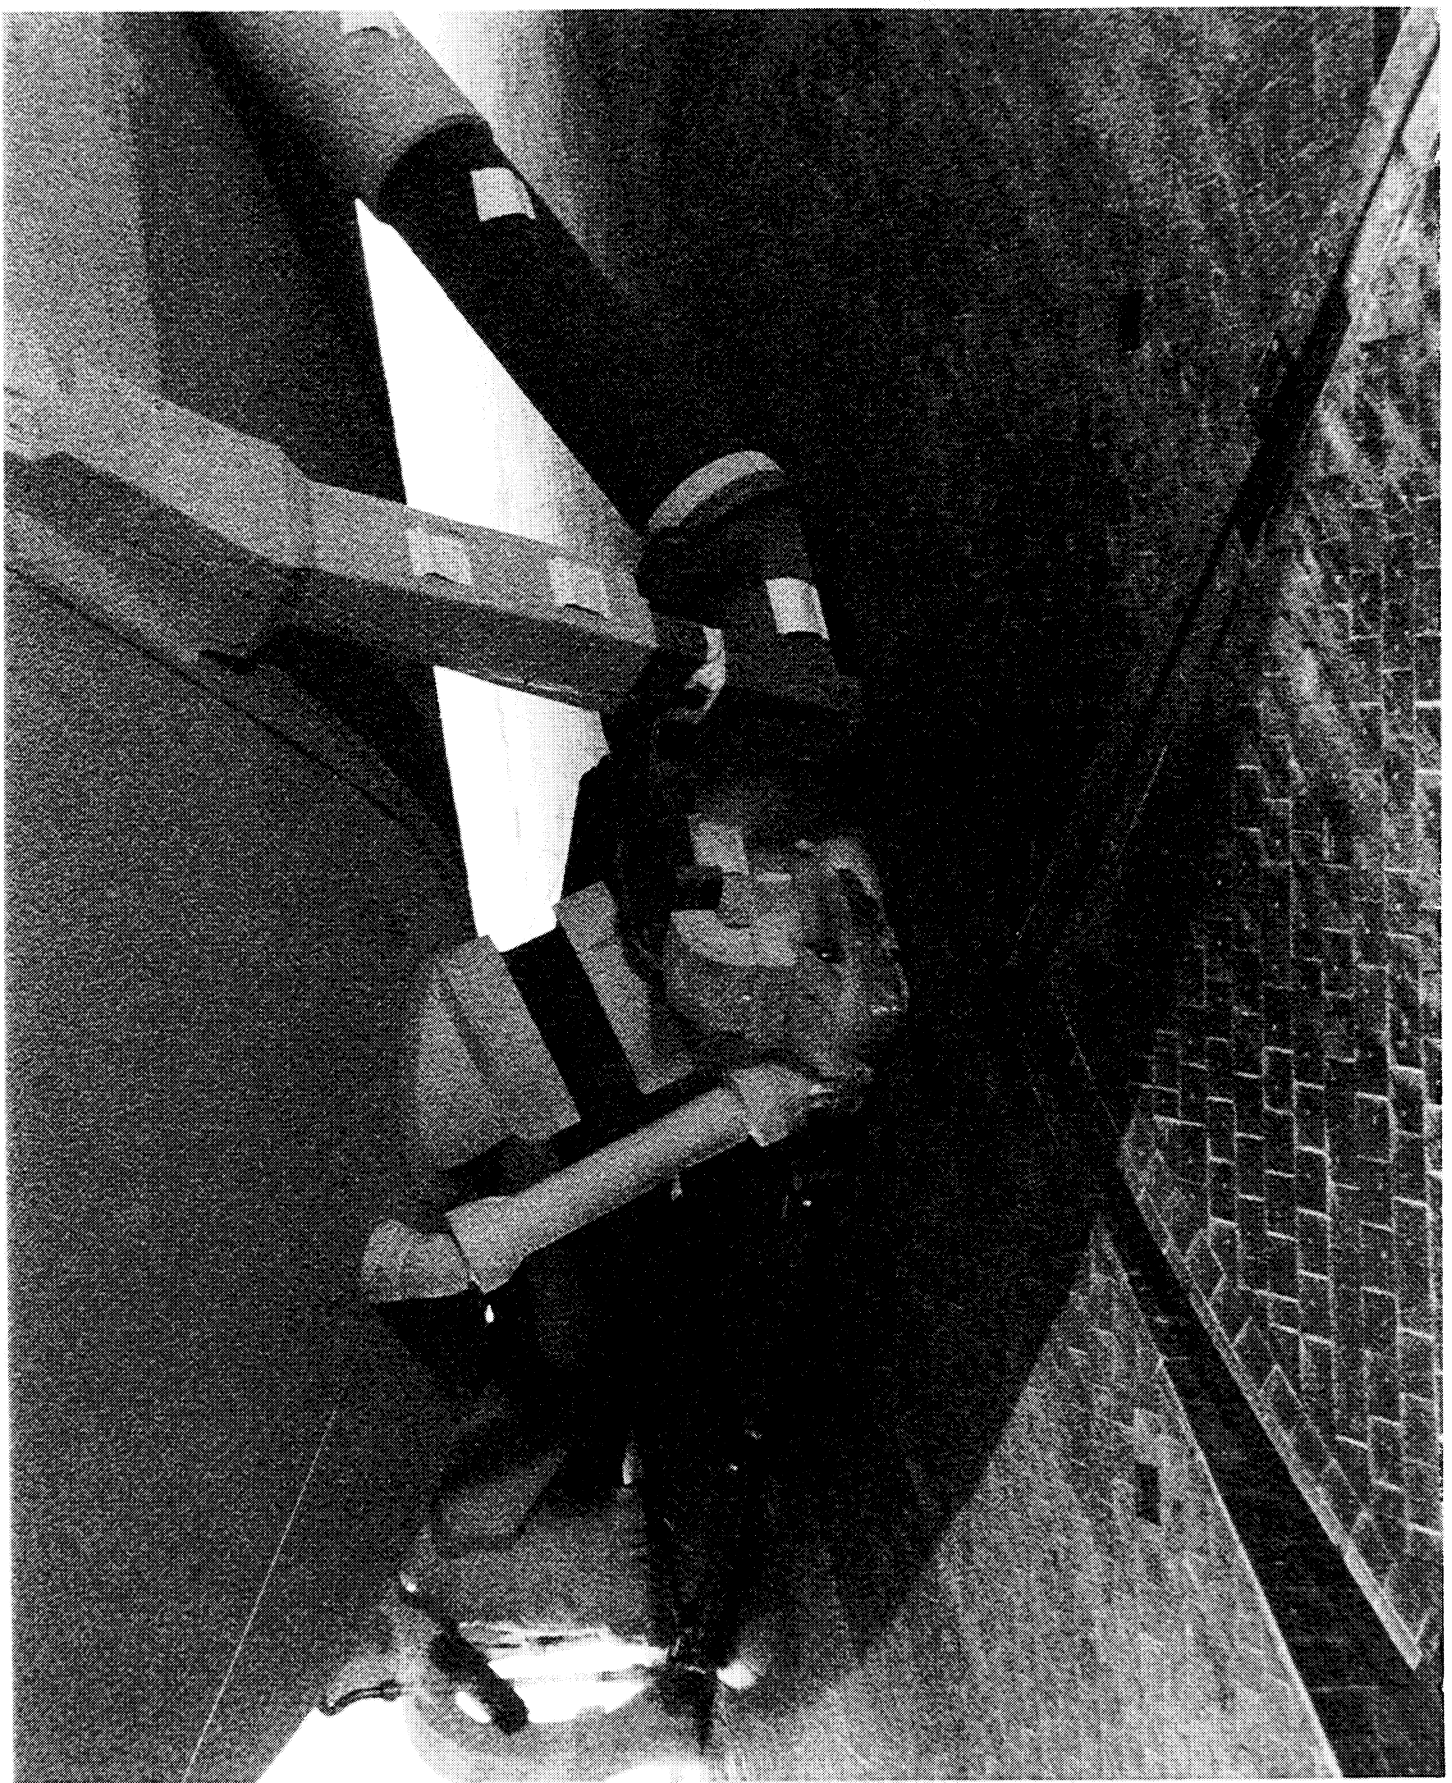
Photo 4: ET/Orbiter LH2 Umbilical

Typical amounts of ice/frost had accumulated on the LH2 ET/ORB umbilical purge barrier outboard side and forward surface. Smaller than usual ice/frost fingers were present on the pyro canister and plate gap purge vents. No unusual vapors or cryogenic drips had appeared during tanking, stable replenish, and launch. All TPS repairs on the umbilical were nominal.

Typical amounts of ice/frost had accumulated on the LH2 ET/ORB umbilical purge barrier outboard side and forward surface. Typical ice/frost fingers were present on the pyro canister and plate gap purge vents.

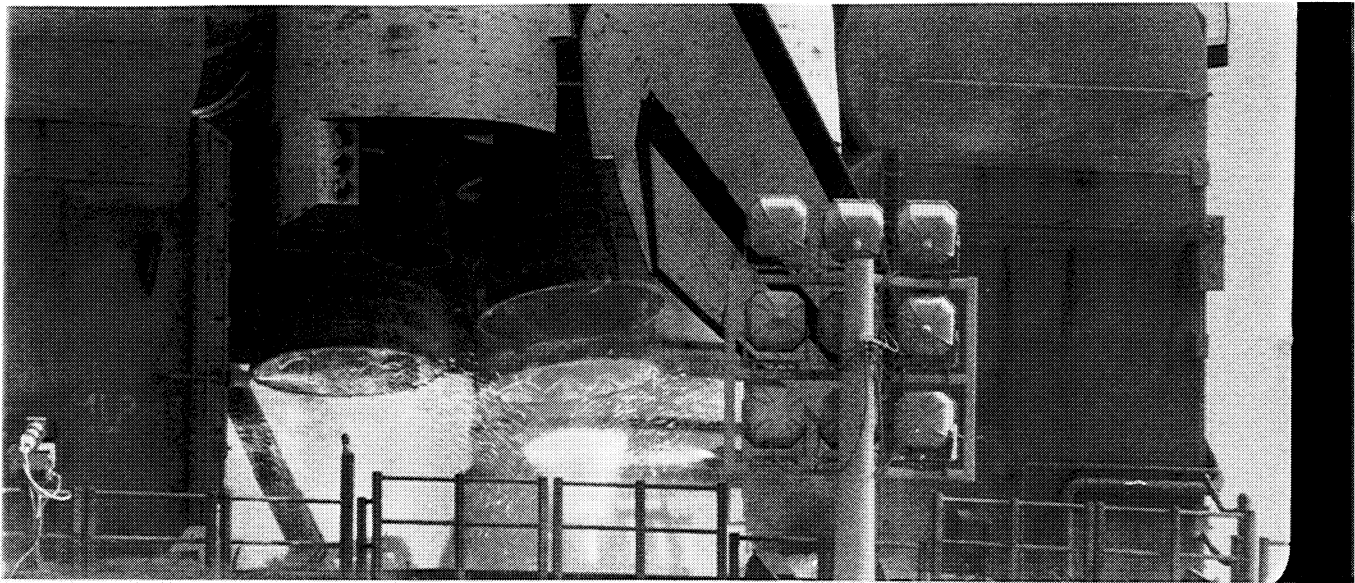
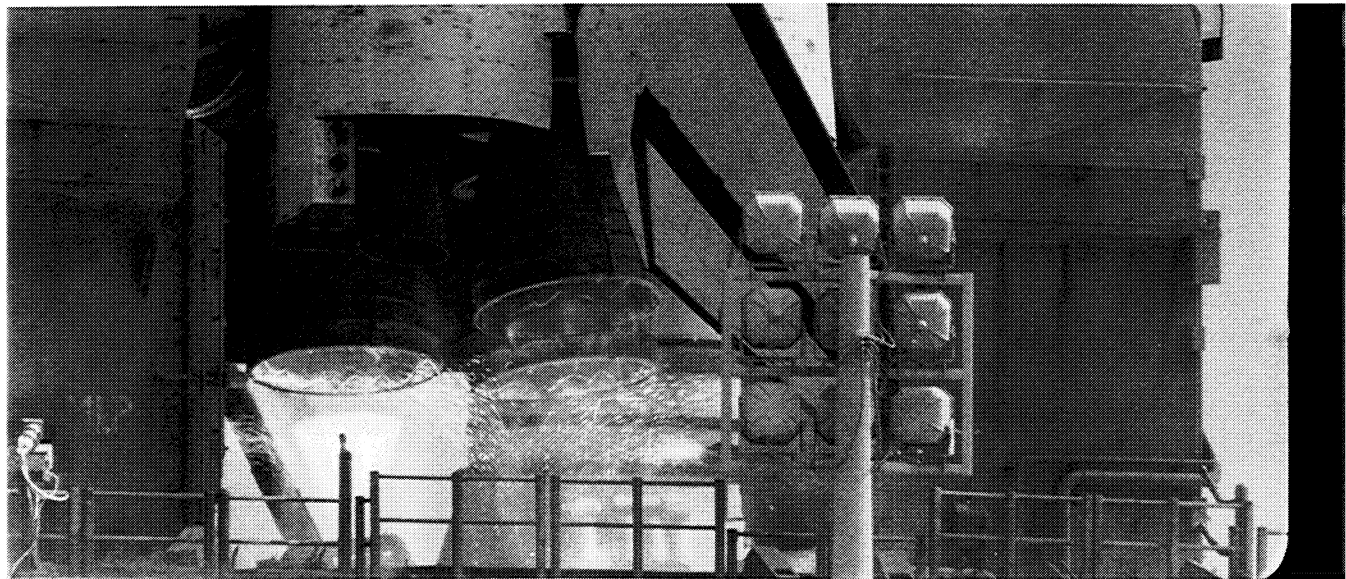
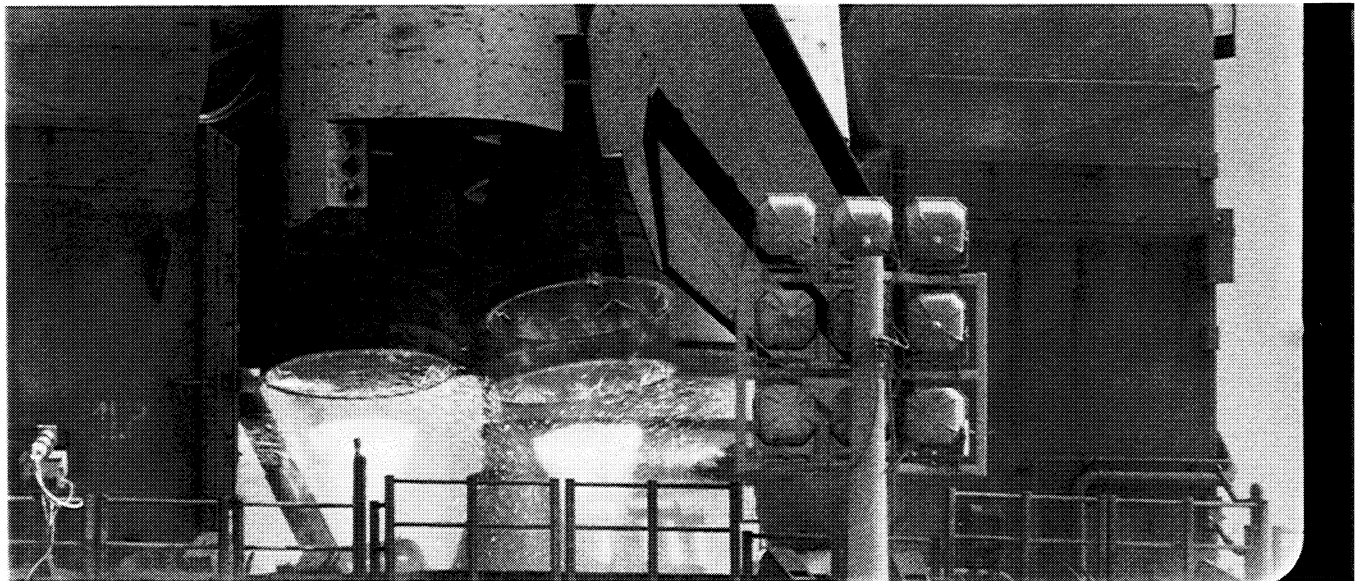
Photo 6: SSME Mach Diamond Formation

As reported by MSFC, the apparent dissipation of the Mach diamond correlates with an oscillation in main chamber pressure that is associated with a characteristic hydrodynamic stall and recovery of the high pressure oxidizer pump. The unusual disappearance and reappearance of the Mach diamond is a combination of factors including the pump stall phenomenon, main chamber pressure level, nozzle physical uniqueness, and external environmental conditions.

During SSME start-up, the SSME #3 Mach diamond formed, disappeared then reappeared later after the SSME #2 Mach diamond had formed

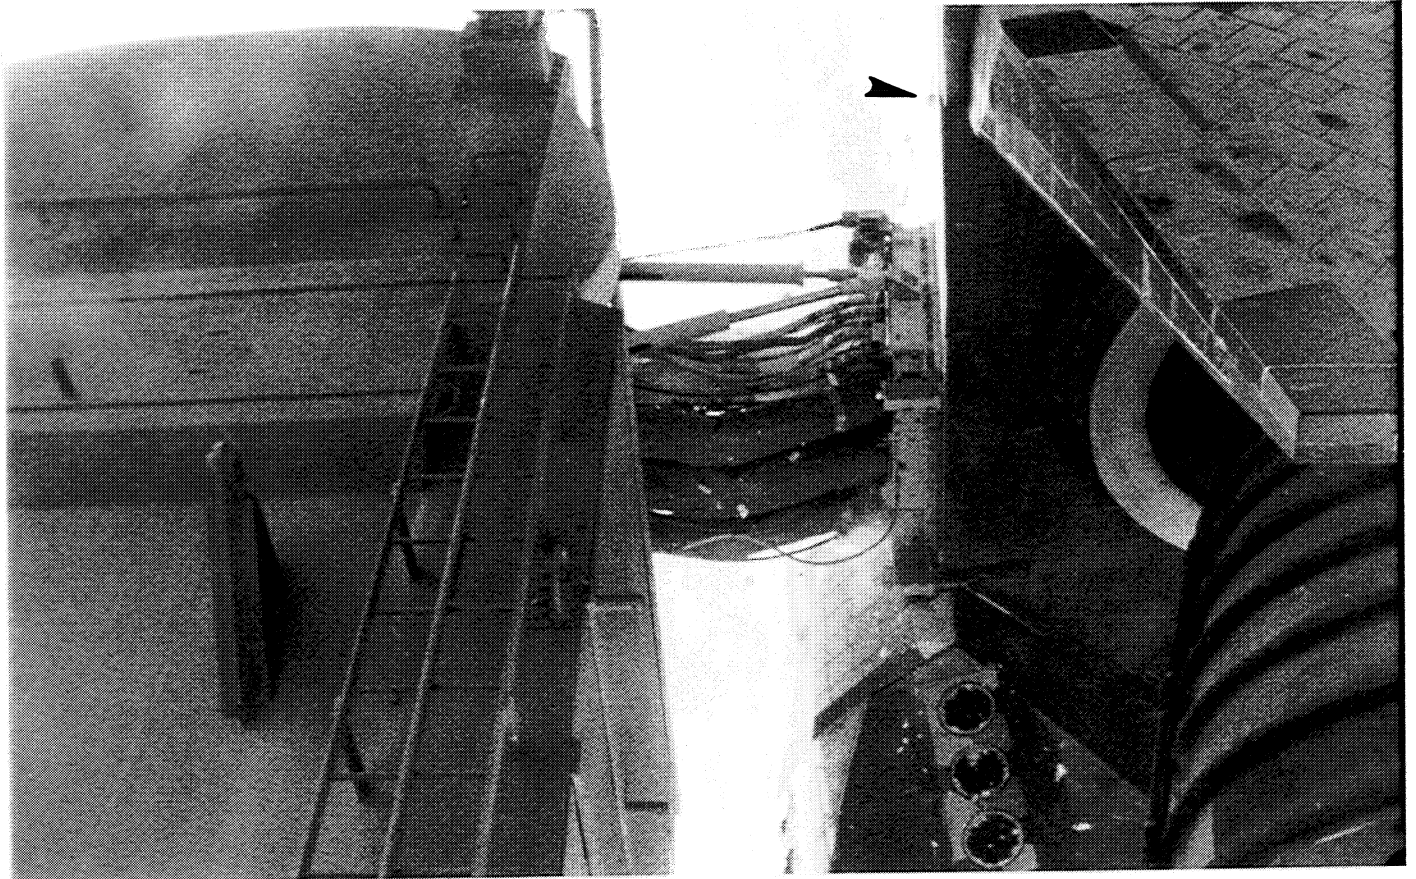
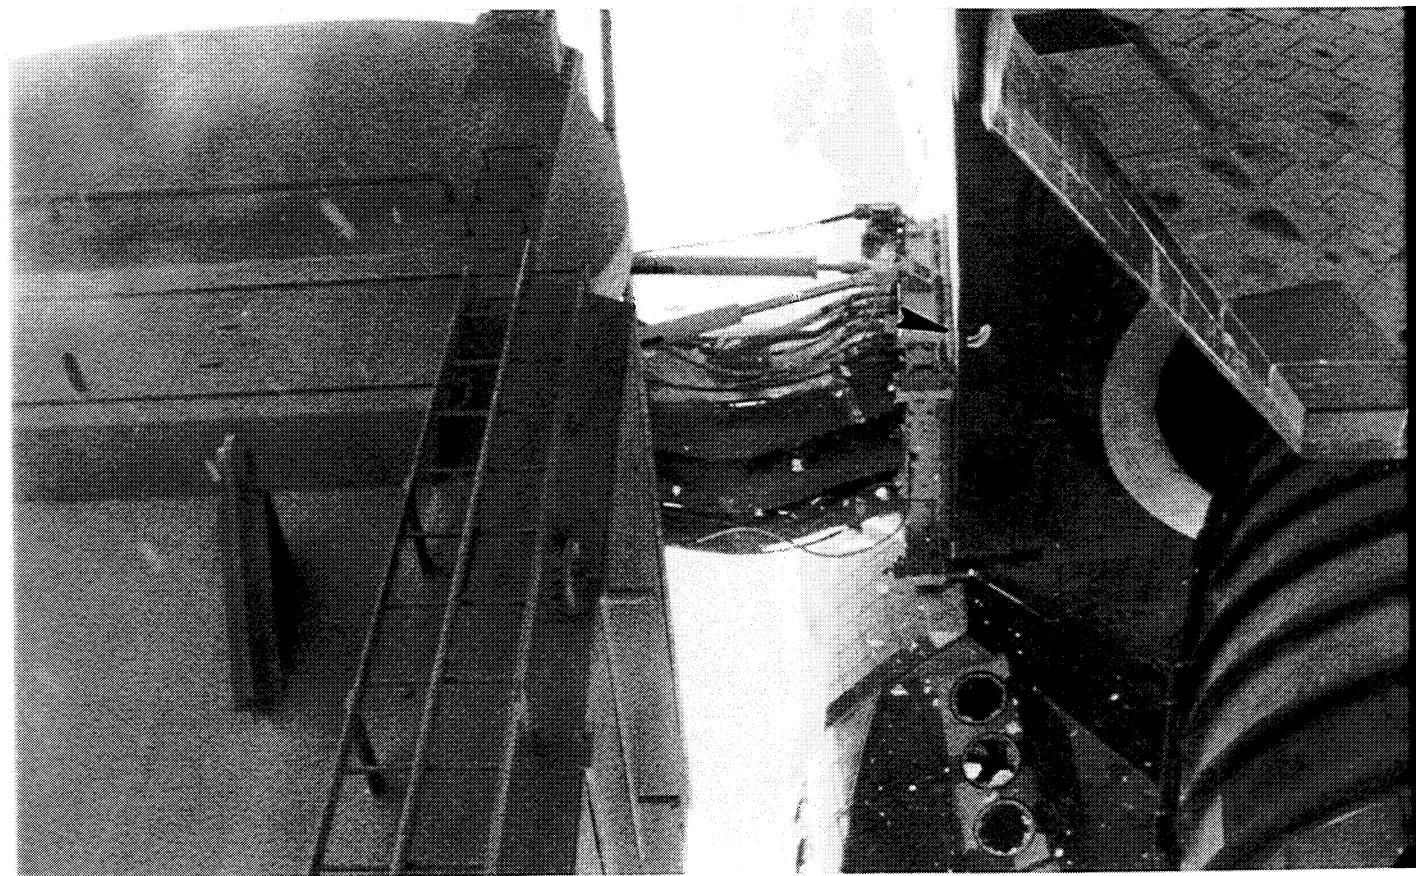
Photo 7: FES Thermal Isolator

A piece of the Macor ceramic thermal isolator fell from the right aft fuselage Flash Evaporator System (FES) port during SSME ignition at 40:56.774 UTC

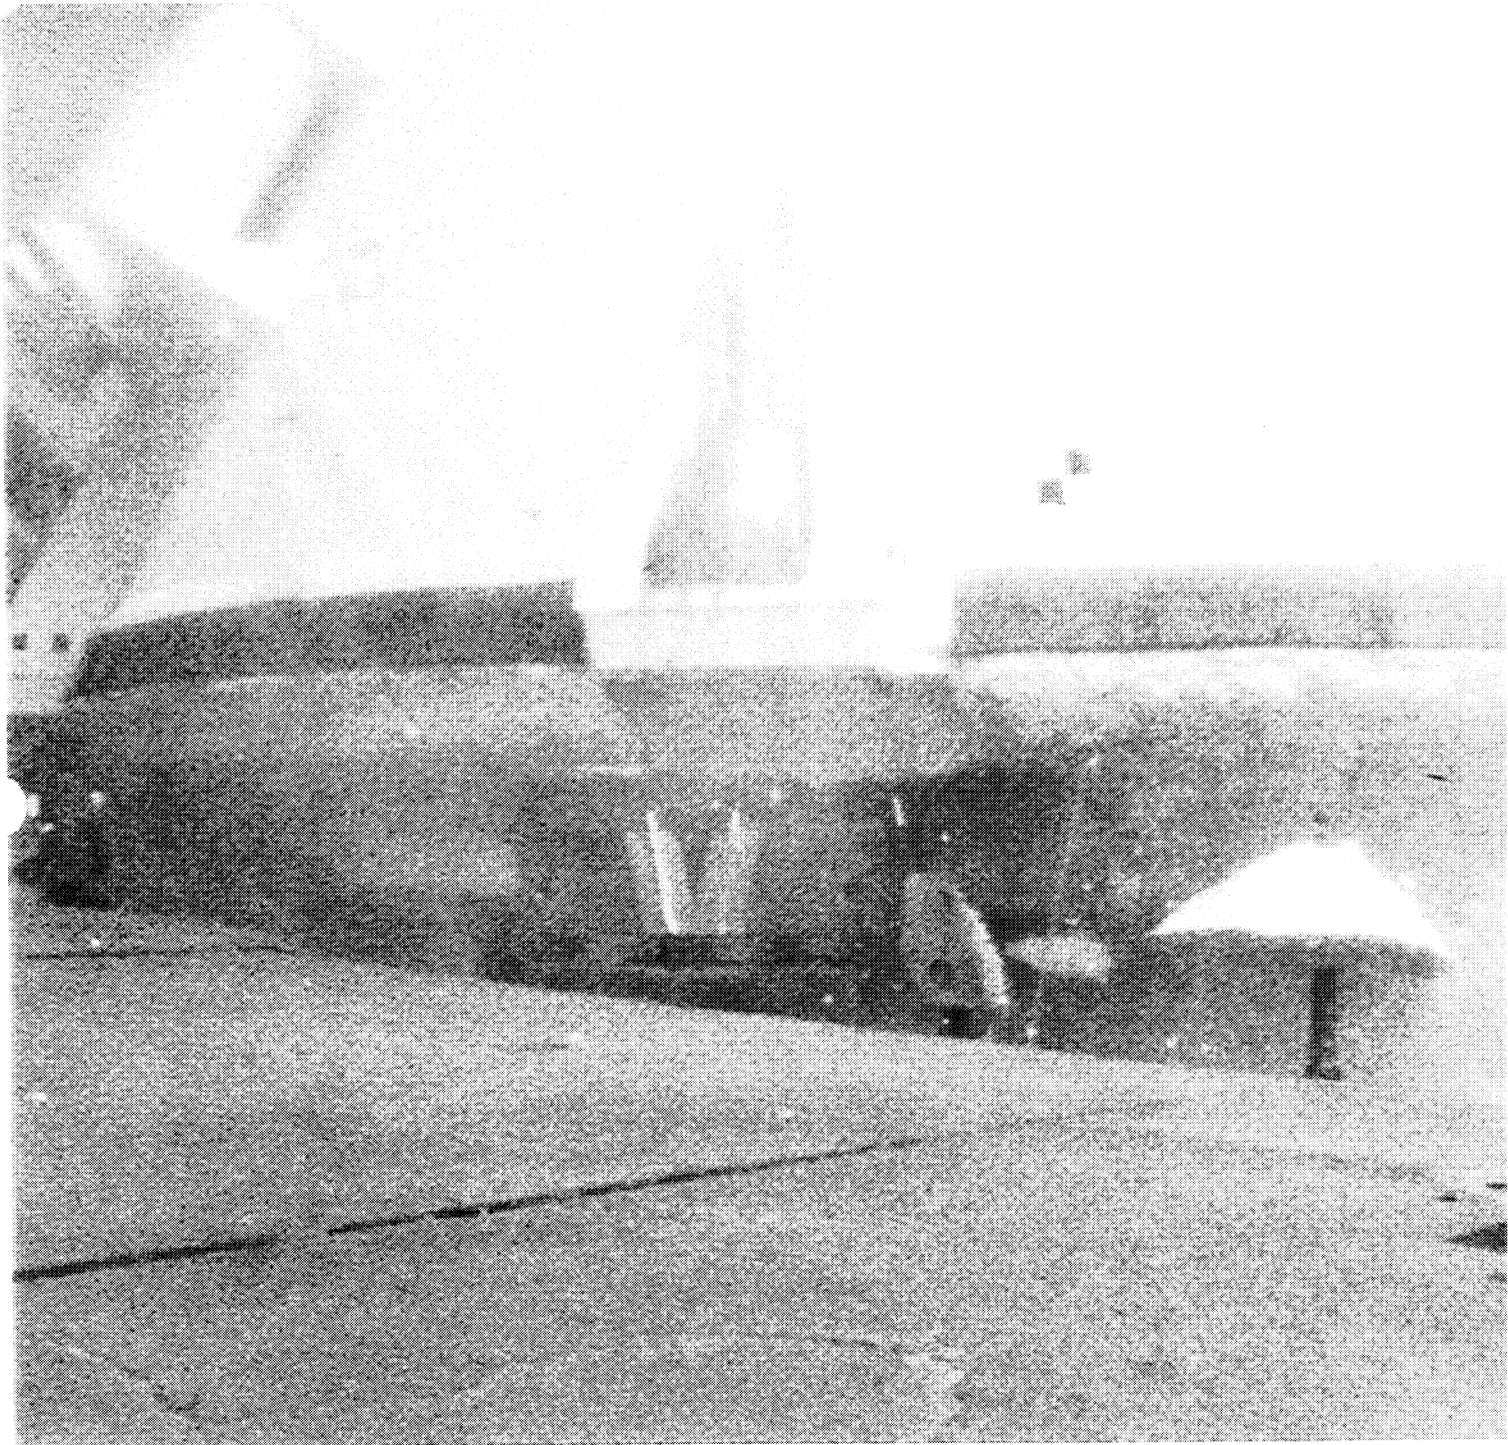
Photo 8: Foam on GN2 Purge Line

A large, 12-14 inch diameter, 12-inch thick piece of instafoam was pulled loose from the right SRB aft skirt as the vehicle began to rise. The foam remained attached to the GN2 purge tube while in the field of view (E-8).

A 12-14 inch diameter, 12-inch thick piece of instafoam was pulled loose from the right SRB aft skirt as the vehicle began to rise. The foam remained attached to the GN2 purge tube while in the field of view.

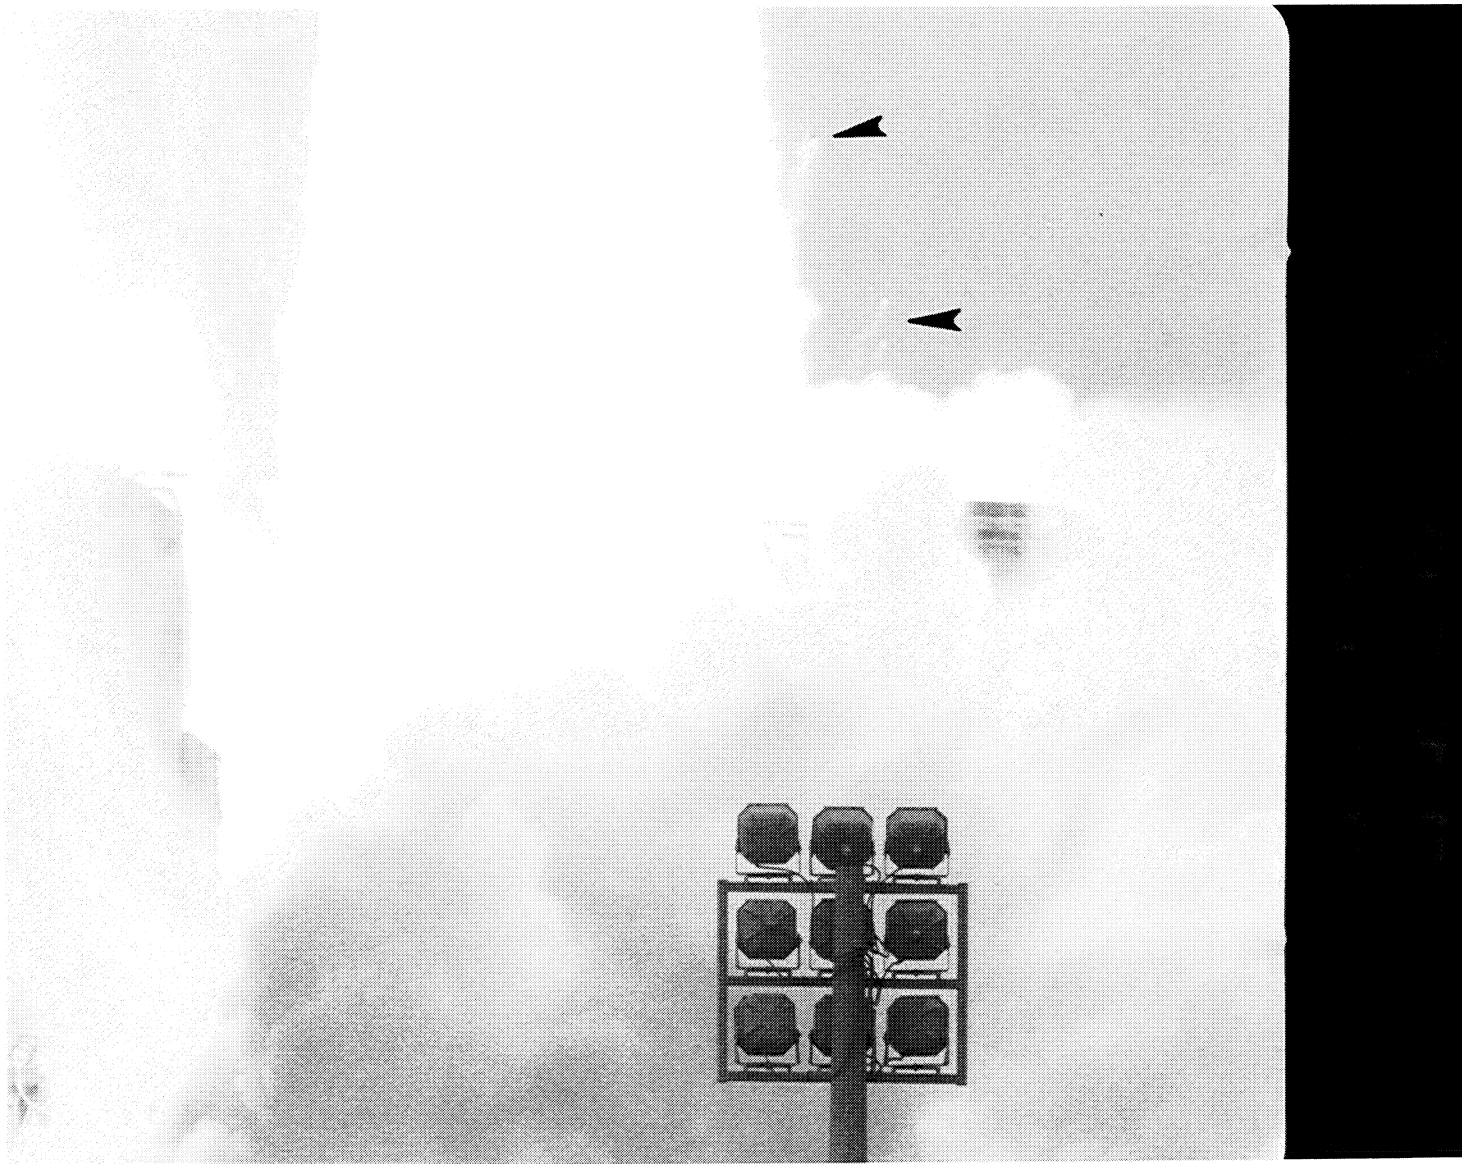
Photo 9: Foam with Smoke Trails

Three debris objects with smoke trails were observed moving away from the right SRB exhaust plume at 14:41:02.766 UTC. (E-20, -63, -77; OTV 033). Good film resolution permitted the identification of the debris objects as chunks of foam originating from the southeast corner of the right SRB exhaust hole. The six pieces of foam debris, three of which exhibited smoke trails, are believed to be instafoam from the right SRB aft skirt pulled loose at liftoff by the GN2 purge line. The heat of the SRB exhaust plume caused the foam to either burn or outgas resulting in the smoke trails.

Three debris objects with smoke trails moved away from the right SRB exhaust plume at 14:41:02.766 UTC. Good film resolution permitted the identification of the debris objects as chunks of foam originating from the southeast corner of the right SRB exhaust hole. The pieces of foam are believed to be instafoam from the right SRB aft skirt pulled loose at liftoff by the GN2 purge line. The heat of the SRB exhaust plume caused the foam to either burn or outgas resulting in the smoke trails.

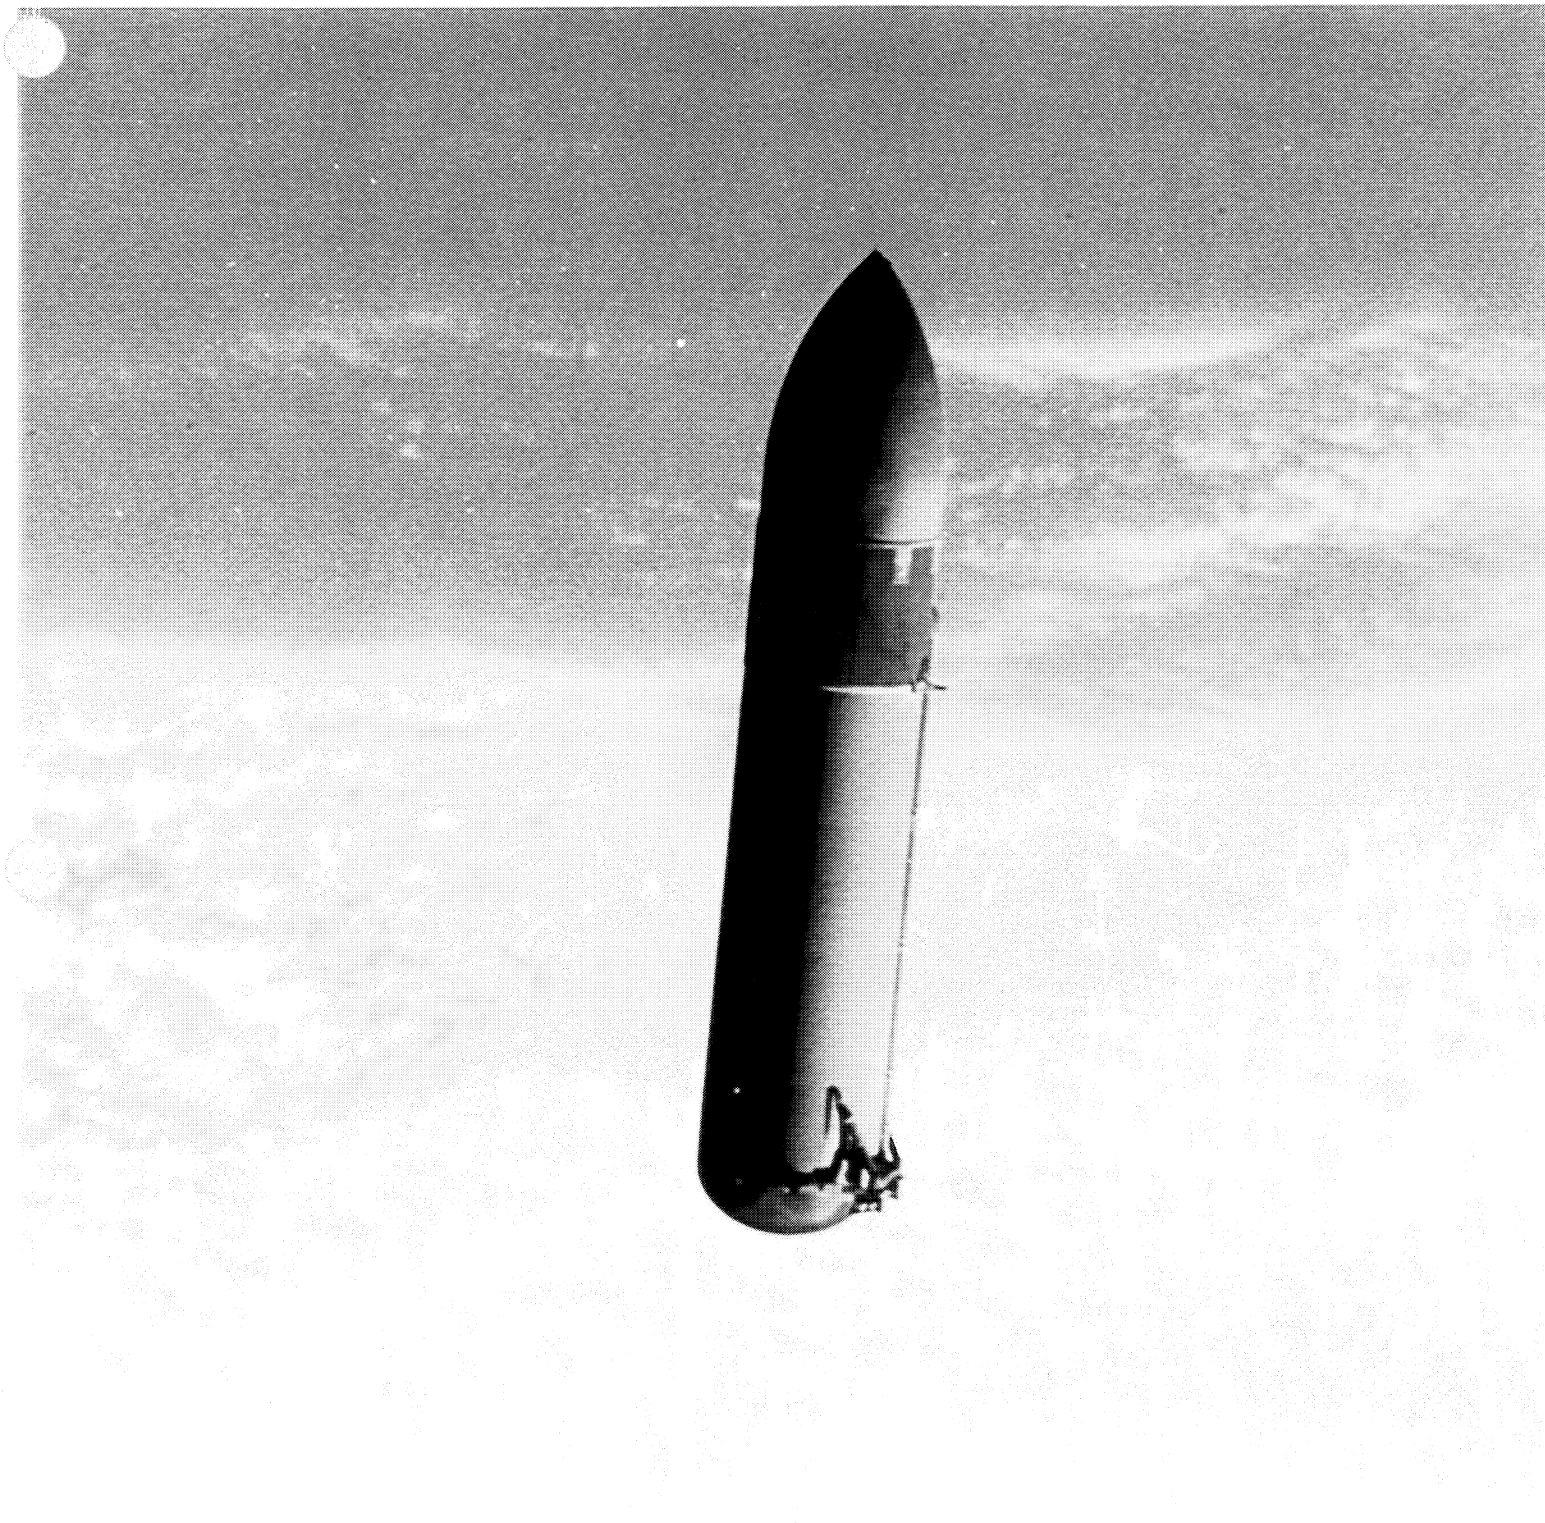
Photo 10: ET Separation from Orbiter

Flight crew hand-held view of the External Tank after separation from the Orbiter showed no anomalies

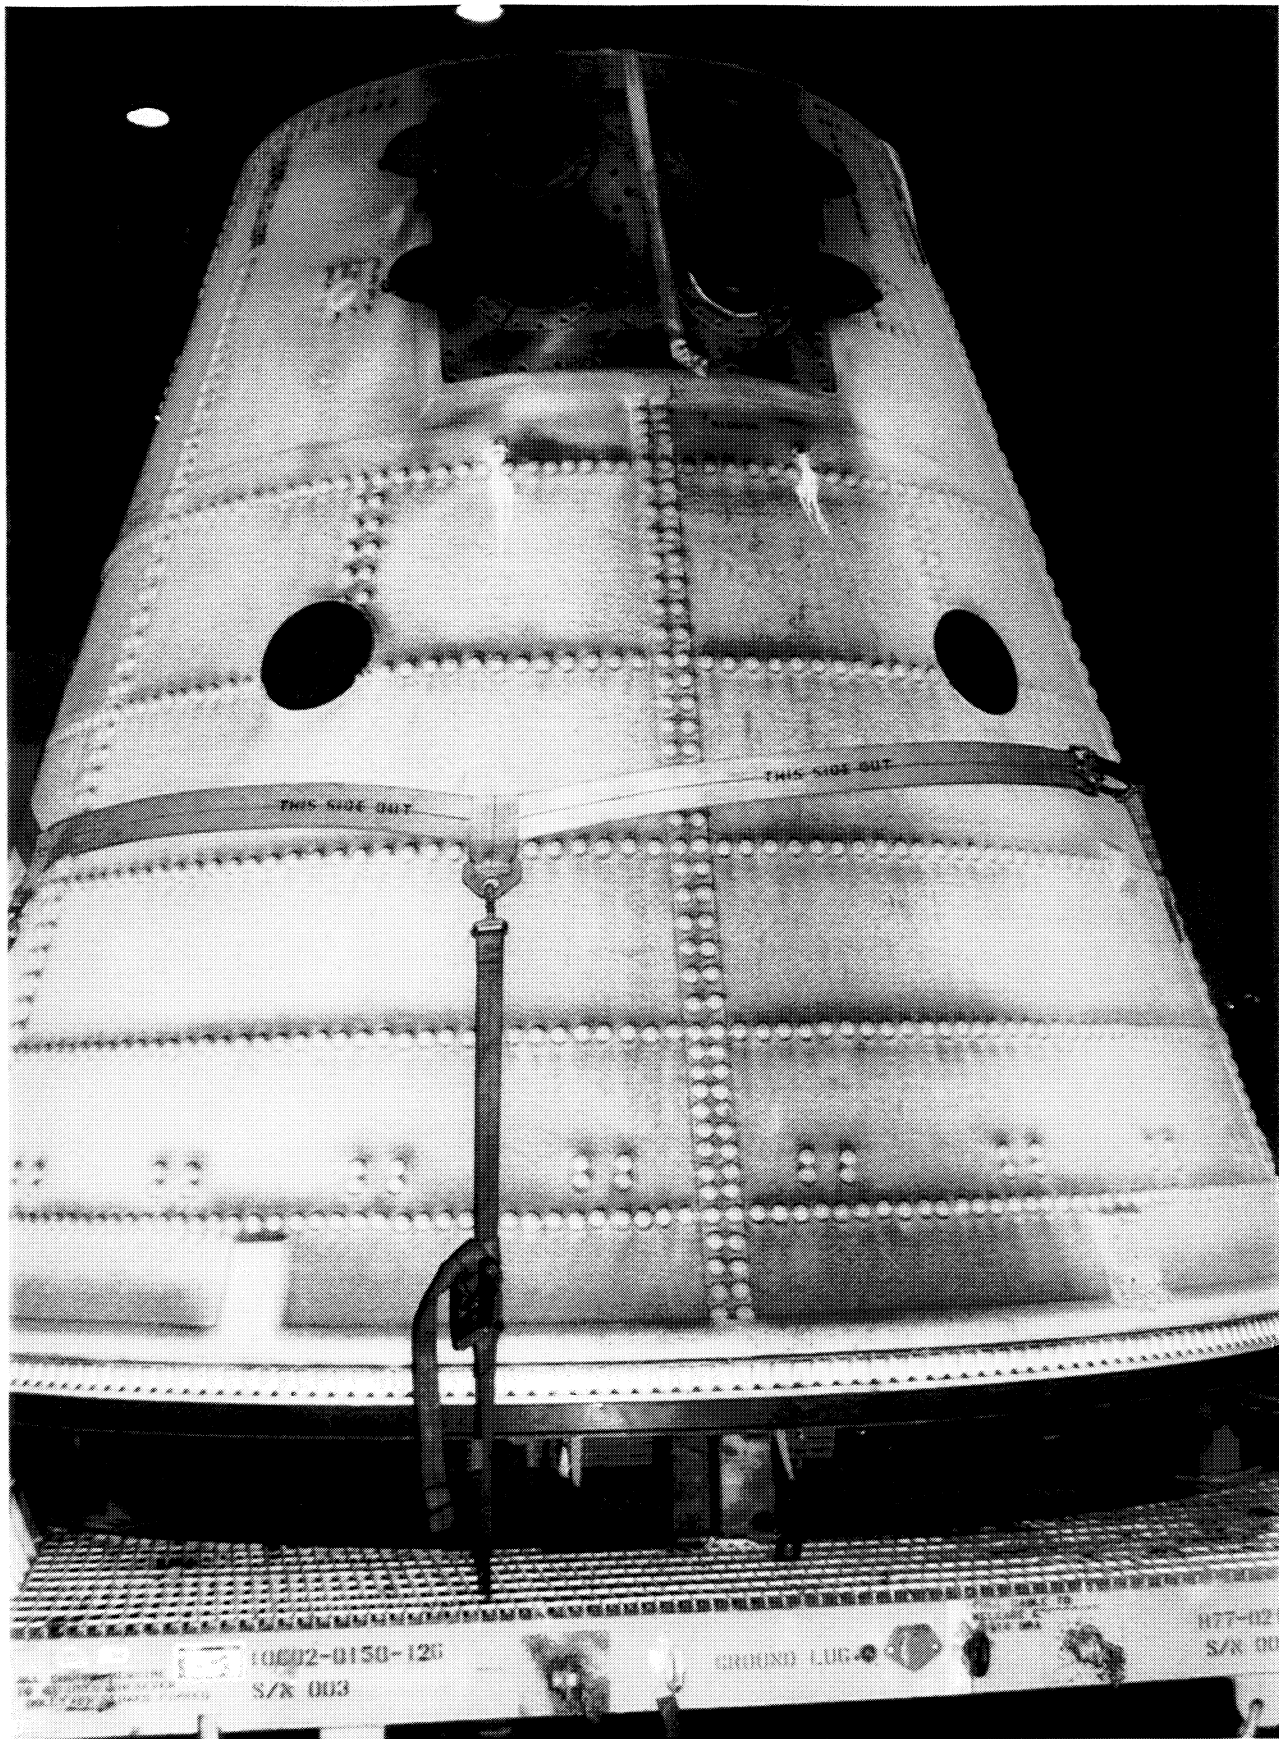
Photo 11: Frustum Post Flight Condition

Both frustums were in excellent condition. No TPS was missing and no debonds/unbonds were detected over fasteners. Virtually none of the Hypalon paint had blistered. All eight BSM aero heat shield covers had locked in the fully opened position.

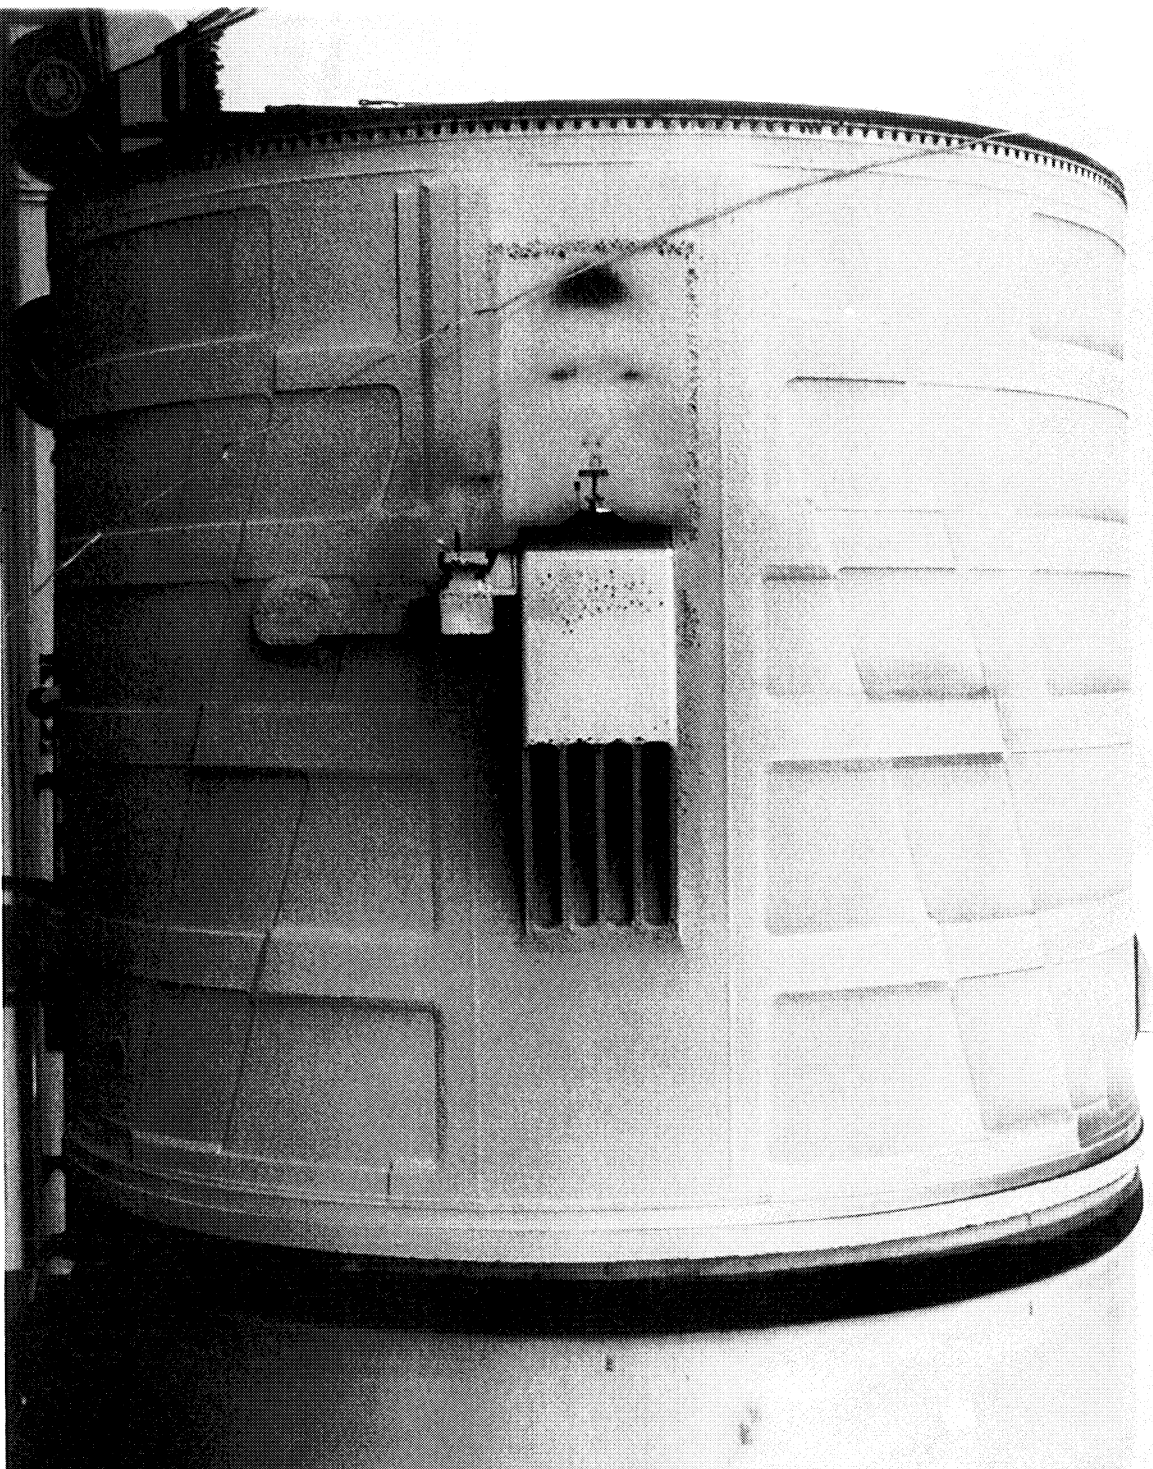
Photo 12: Forward Skirt Post Flight Condition

The forward skirts exhibited no debonds or missing TPS. RSS antennae covers/phenolic base plates were intact. The +Z antenna base plate on the left SRB exhibited two delaminated phenolic layers. Hypalon paint was blistered/missing over the areas where B1A closeouts had been applied. All frustum severance ring pins and retainer clips were intact.

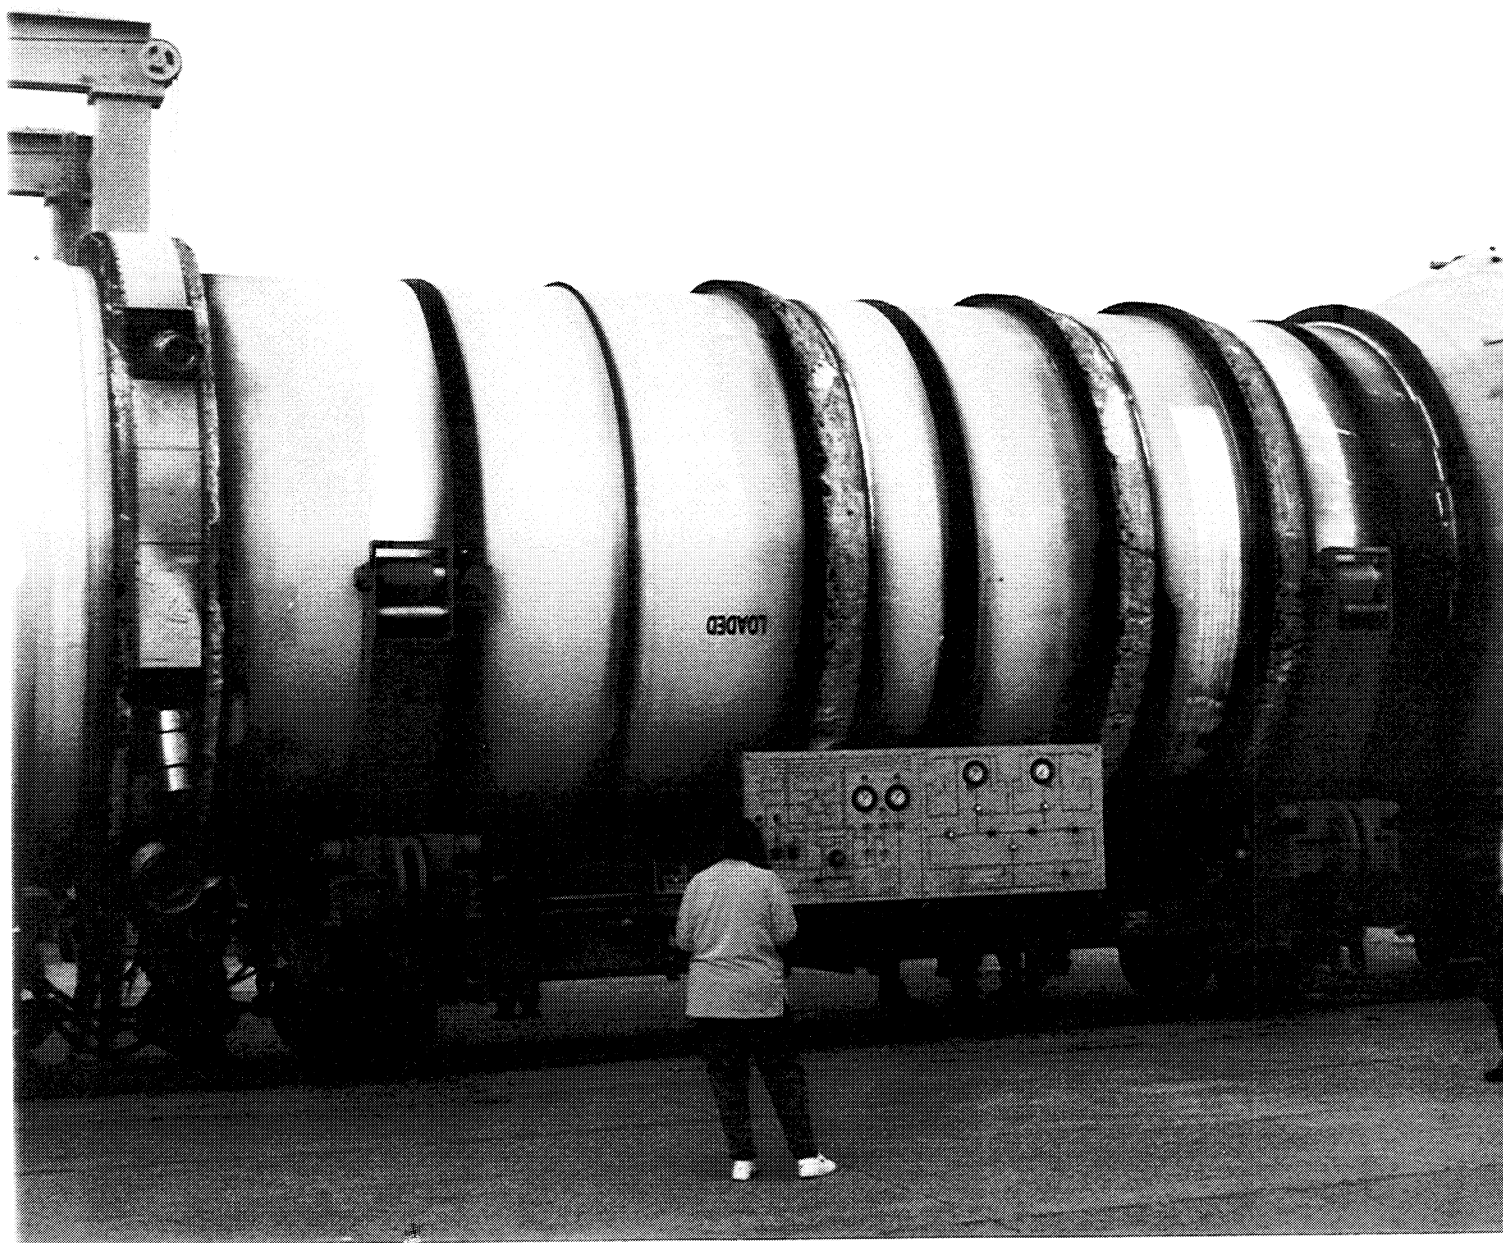
Photo 13: Aft Booster/Aft Skirt Post Flight Condition

Separation of the aft ET/SRB struts appeared normal.
Several stiffener rings and the left SRB IEA were damaged by water impact.
